# Railroad Preemption Issues

Rob Ziemba, PE  
S&G Railroad and Special Projects Engineer

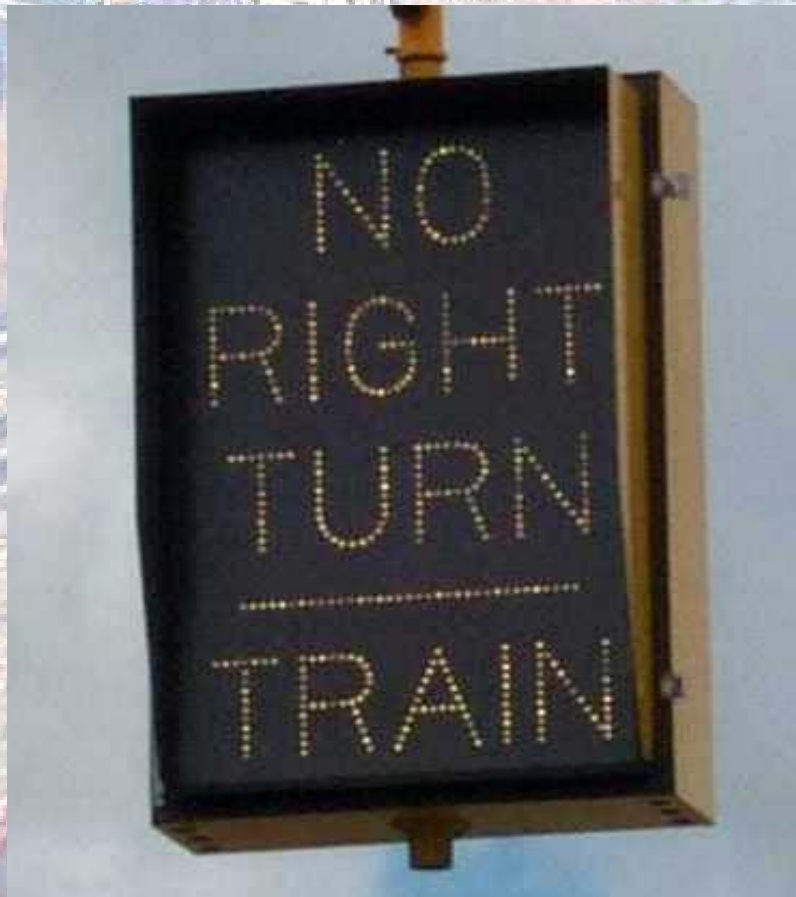
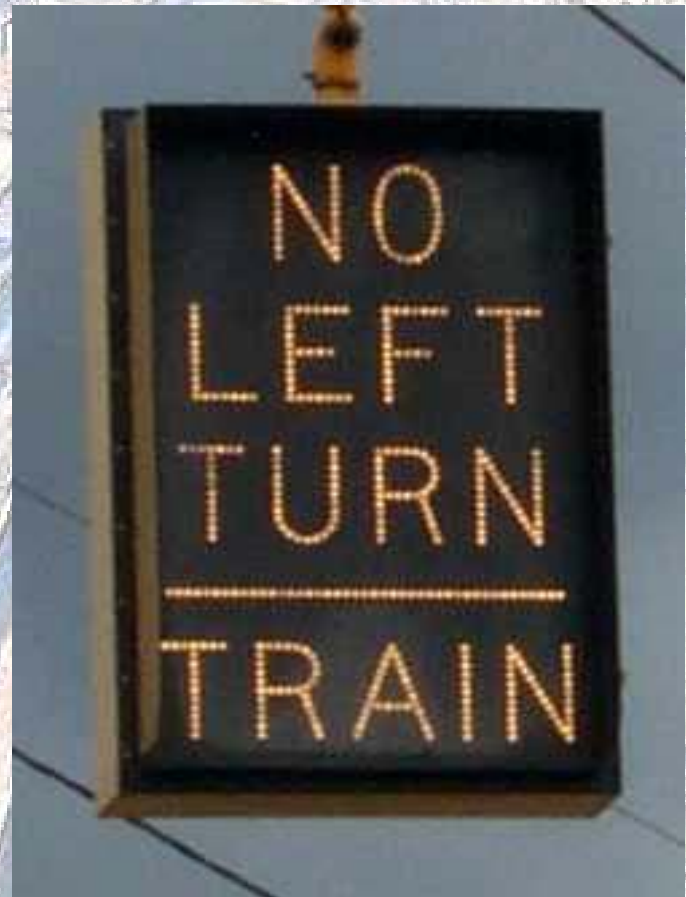
Existing signs used in NC

- Original signs were Vericom (Fold out) or Internally Illuminated signs - These should be replaced
- Current standard for new signs is LED
- Fiber Optic signs recently installed are OK for remainder of their useful service life

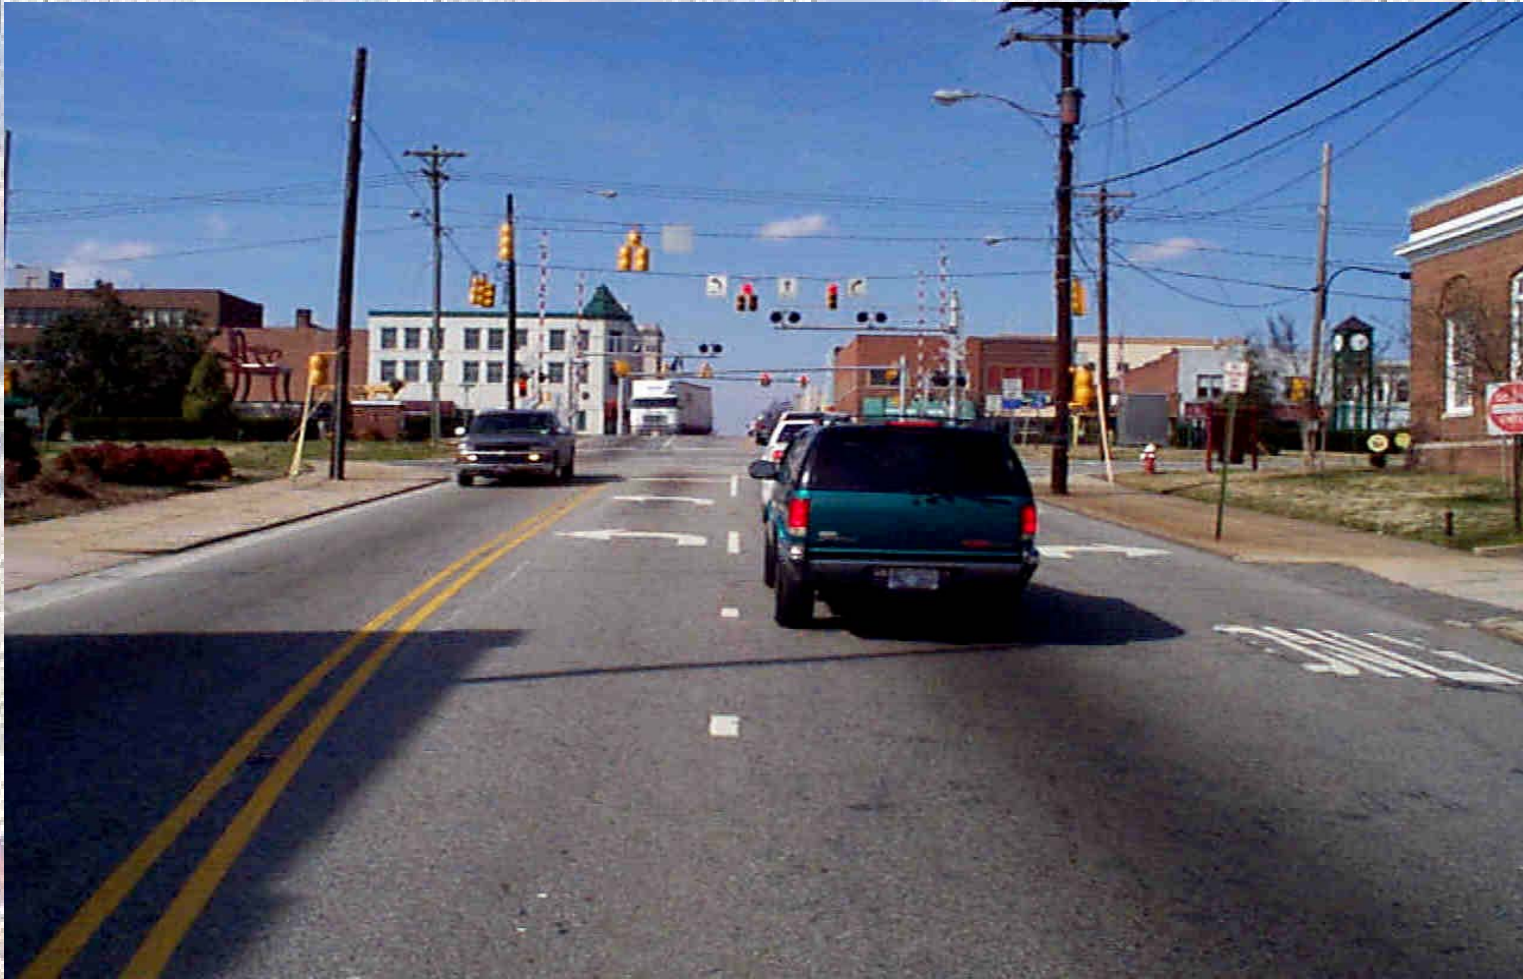
Downtown Thomasville at the Big Chair

- “The Big Chair” - Randolph St. (NC 109)
- Signalized intersections on both sides of tracks (operate from same controller)
- Downtown urban setting (2 lanes, 20 MPH) with on street parking, pedestrians, heavy truck traffic, and multiple driveways
- NS mainline with ~50 trains/day and top speed of 79 MPH protected by 4 quadrant gate system
